Case Study

New Install
Siemens and MHI Compressor Train

This case study presents a detailed overview of 11 high velocity hot oil flushes performed by PetrolinkUSA at a customer's new production facility.

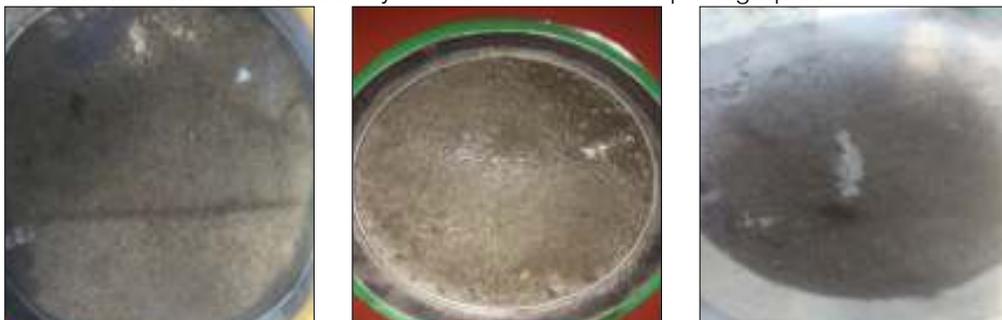
The pictures below illustrate the progression of the system cleanliness and the contamination present on various API 614 screen checks during the project. These screen checks were performed on screens installed in the lube oil and control oil discharge headers of the Mitsubishi and Siemens trains. These screens were inserted at the start of each flush and located at the extreme end of each discharge header before entering each respective console. Each screen reflects the first run and screen pull for each system. The duration of the first runs was 30 minutes. The contamination in each system is evident in these photographs.

Right: Discharge header screen checks after first 30 minutes of flushing

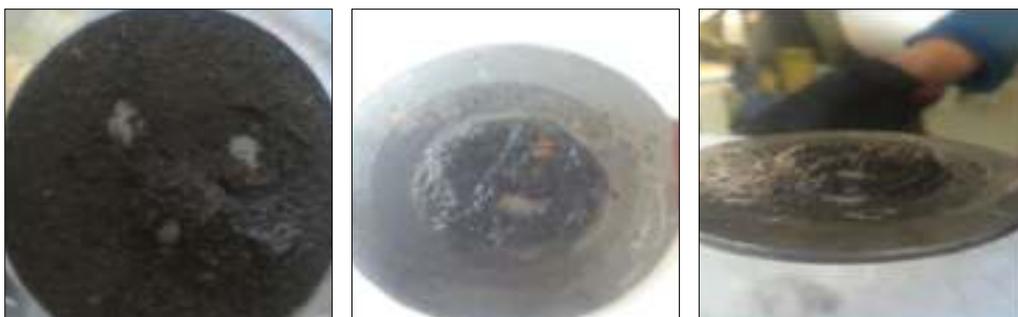
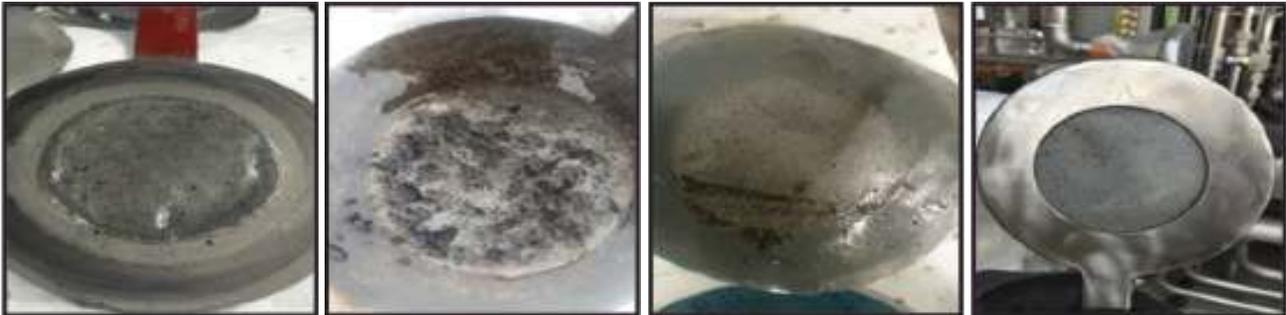
4" Inboard Turbine Supply on Mitsubishi Train 3" Outboard Compressor Supply Line Siemens Train 1.5" Outboard Journal Bearing Supply Line on ThyssenKrupp Train 2" Inboard Thrust Bearing Supply Line on ThyssenKrupp Train

The screens pictured below were located on the discharge end jumper points. These screens helped identify the specific areas of heavy contamination inside the piping. The flow path was then manipulate to target these areas and remove the heavy contamination . Furthermore, it ensures the customer that the most sensitive lines (bearing, gearbox supply lines) are clean before startup. It's critical that these supply lines have little to no contamination present to prevent premature wear or worst case scenario, cause catastrophic failure.

Right: Heavy contamination was found on the screens located at the bearing jumper lines

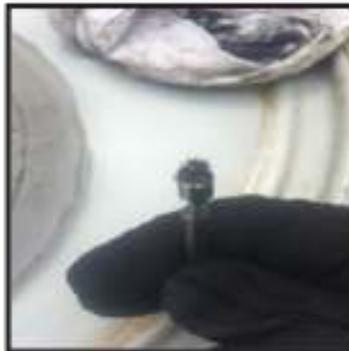
Metallic Debris pulled off screen

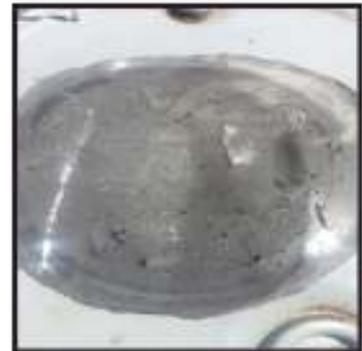
Rubber and Plastic present on screen pull

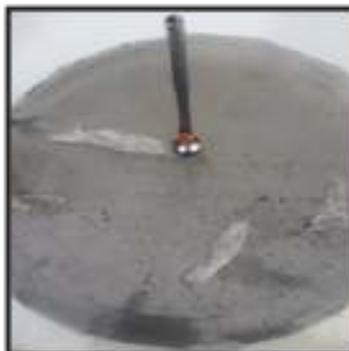
Plastic found on 8" screen on end of header

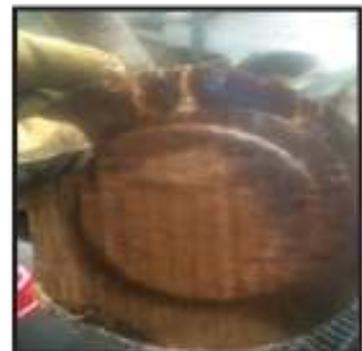
Cardboard found within lube oil piping

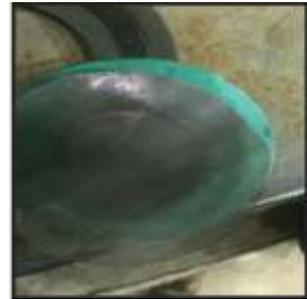
1.5" inboard gearbox supply line ThyssenKrupp

The pictures below show examples of the screens pulled following verification runs. These lack of particulates on the screens clearly indicate the systems had met the required cleanliness specifications.
