Case Study

Major Petroleum Refinery
Process Gas Compressor
Chemical Clean & HVOF

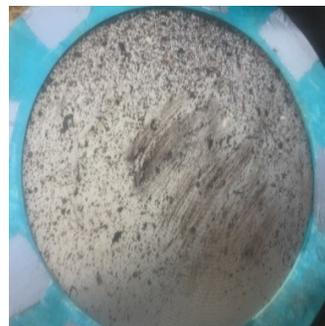
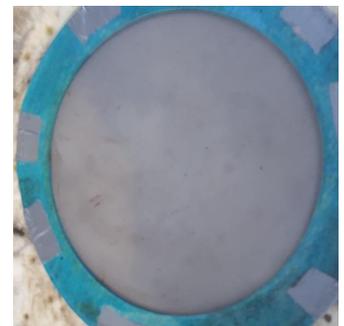
Before **After**
API 614 Screen on 6" Return Line

The system was reconfigured to utilize the organic system reservoir and the existing oil for a high velocity oil flush. During rig up valves were installed at every bearing supply point to ensure high velocities system wide. A targeted plan was utilized to isolate every part of the system using the for mentioned valves along with alternating flow between heat exchangers and filter vessels. The heat exchanger bundles were reinstalled once the vast majority of contamination had been removed from the system and included in the flush. Once verification screens were in accordance with API 614 and approved by the client, the total flush time ended at approximately 51 total hours.

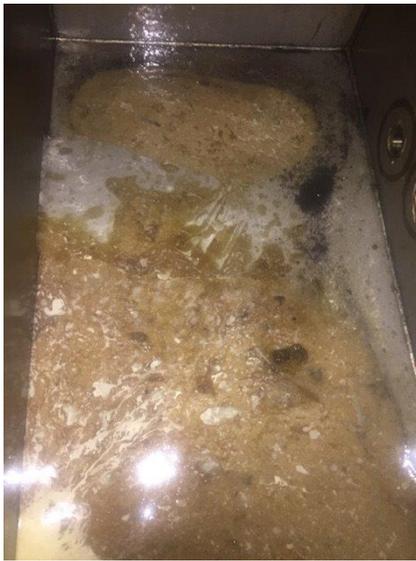
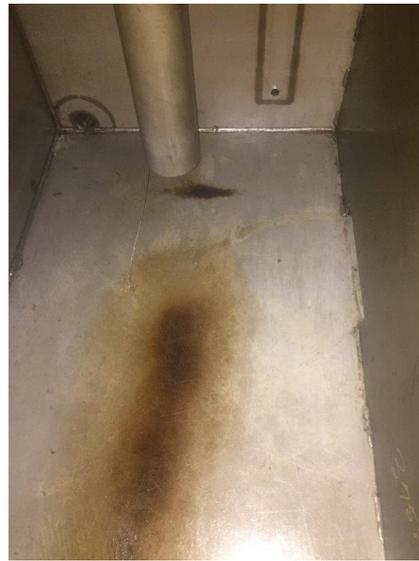
Reservoir Cleaning Results

Before

After

The oil was purged and drained from the system and disposed of at the clients preference. With the oil removed, PetrolinkUSA moved forward with the reservoir cleaning. Once clean, new oil was filter filled into the system using one micron BETA 1000 micro-glass filters. Oil analysis resulted in a 13/12/8 ISO particle count.
