## TEXAS REFINERY: WET GAS COMPRESSOR LUBE OIL SYSTEM HIGH VELOCITY HOT OIL FLUSH

Larry B. Jordan | PETROLINKUSA

PetrolinkUSA performed flushing services on a Wet Gas Compressor Lube Oil System at a Texas Refinery. Services provided included a high velocity hot oil flush, reservoir cleaning and side stream filtration of the final fill oil.

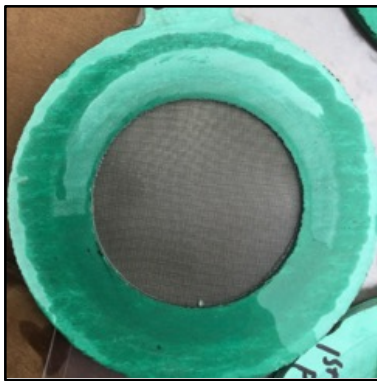
**Figure 1.** Motor inboard bearing first inspection 2/23/18 7:50AM

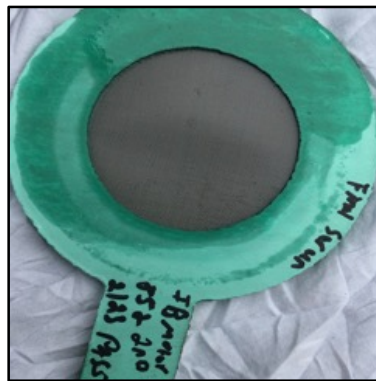
**Figure 2.** Motor inboard bearing final approved inspection screen 2/23/18 8:52AM

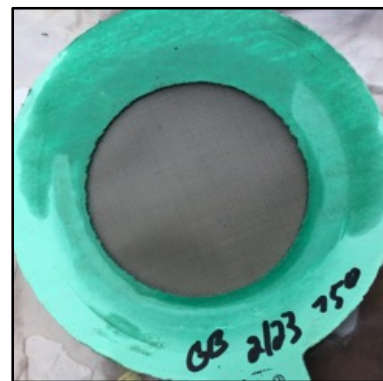
**Figure 3.** Gearbox approved first inspection screen 2/23/18 7:50AM

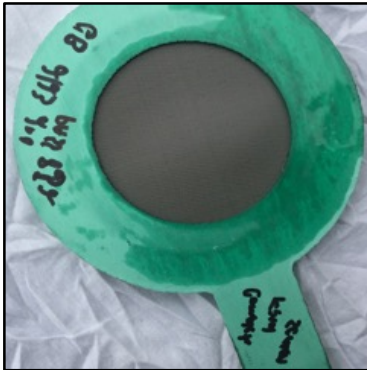
**Figure 4.** Gearbox approved second (confirmation) pass inspection screen 2/23/18 8:52AM

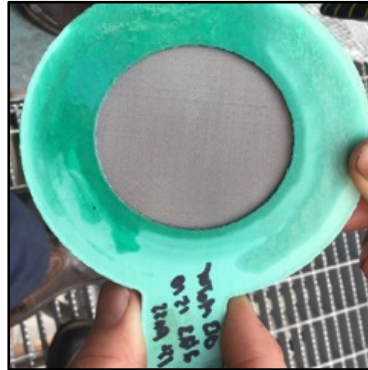
**Figure 5.** Motor outboard bearing approved first inspection 2/23/18 3:10PM

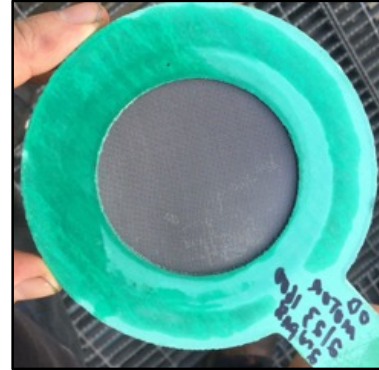
**Figure 6.** Motor outboard bearing approved second (confirmation) inspection 2/23/18 4:00PM

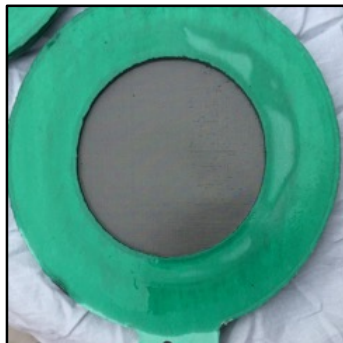
**Figure 7.** Compressor outboard bearing approved first pass inspection screen 2/23/18

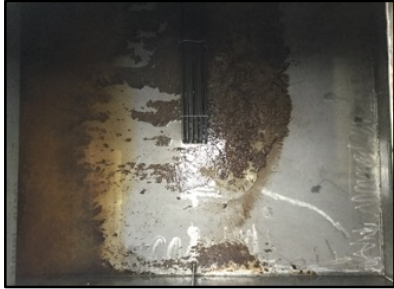
**Figures 12a & 12b.** Interior of the Wet Gas lube oil reservoir before cleaning (left) and post cleaning (right).

The Wet Gas lube oil reservoir was cleaning on Day 6. The reservoir was blinded for Confined Space Entry (CSE) before breaking the plane into the reservoir. PetrolinkUSA personnel entered and cleaned the interior of the reservoir. The condition of the cleaned reservoir was inspected and approved by Refinery representatives. The reservoir blinds were removed and a new 1.5" valve for the sample port was installed by site contracted pipefitters.

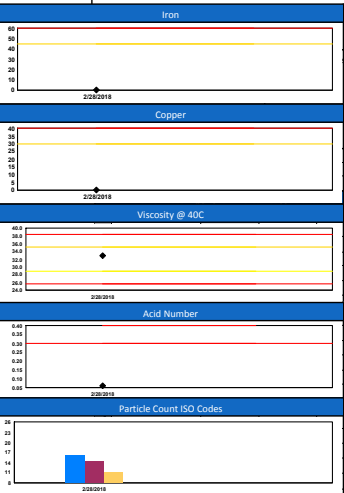
Particle Count ISO Codes	Count
>4 Micron	682
>6 Micron	265
>14 Micron	20
>50 Micron	0
>100 Micron	0
